**MARINE INVESTIGATION REPORT**  
**M01L0080**

**GROUNDING**

**CONTAINER SHIP *CAST PRIVILEGE***  
**CANADA MARITIME SERVICES LTD.**  
**OFF ÎLE SAINT-OURS IN THE ST. LAWRENCE RIVER**  
**29 JULY 2001**

Report Number M01L0080

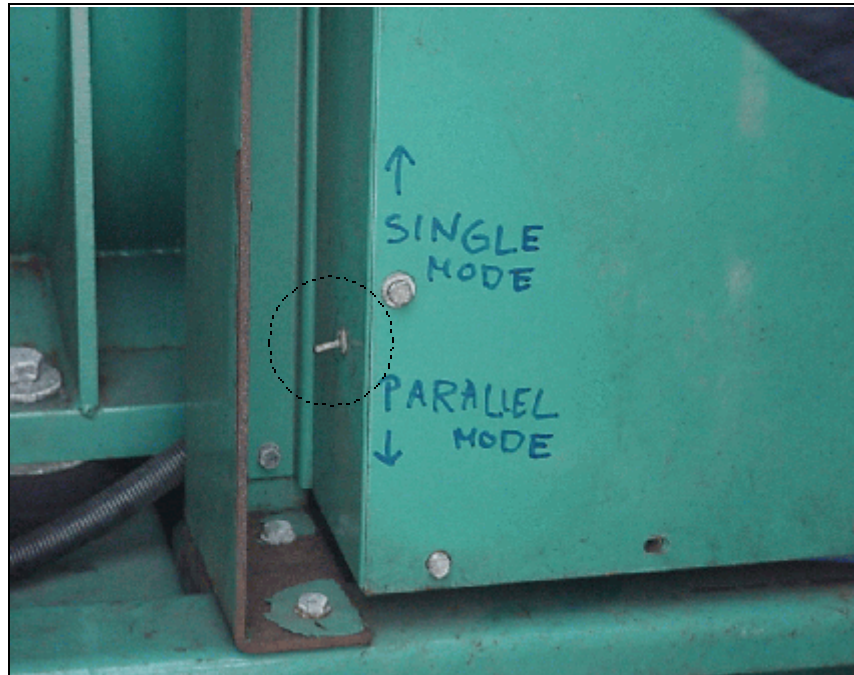
The temporary generator was a containerized Onan, model DFHD 60, manufactured by Cummins Power Generation. It comprised a Cummins diesel engine driving an Onan single bearing alternator. The self-contained unit is equipped with a fully-integrated Power Command Control (PCC) microprocessor-based system, used for monitoring, metering, governing, and voltage regulation. The PCC manages a parallelling function, however by use of a bypass switch on the generator, it is possible to override the PCC system and operate the genset as a stand alone unit (see Figure 1).

Figure 1 - Toggle switch mounted on temporary genset control panel

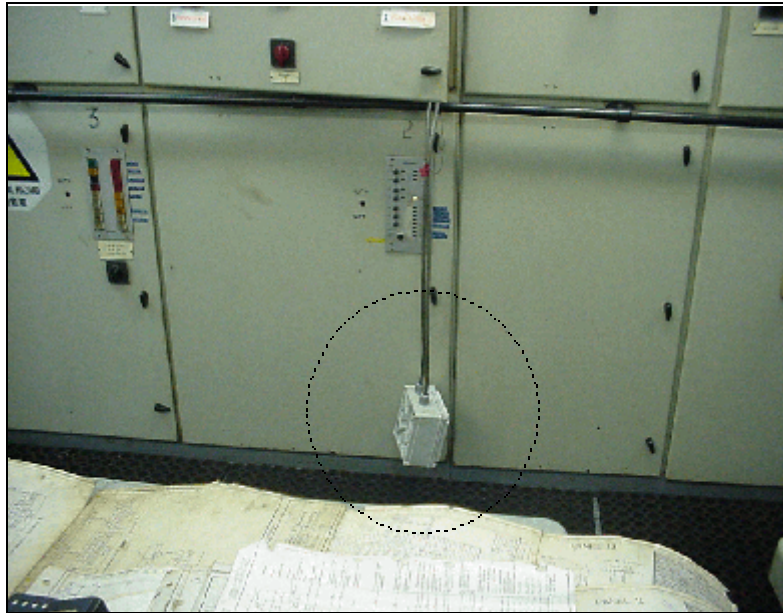
On the vessel's subsequent return to Liverpool on 26 April 2001, additional load and control cables were installed by a shore-based service engineer. This allowed the temporary genset to run at its maximum capacity of 900 kW. As the genset was still not capable of automatically sharing electrical load when running in parallel with the other SSGs, a potentiometer was installed on the main switchboard (see Figure 2), which allowed the crew to balance the load by controlling the genset's governor manually. Parallel tests up to 700 kW were conducted. A written procedure, detailing both stand-alone and parallel operations<sup>2</sup>, was posted at the main switchboard. LR was not requested to attend the vessel at this time and was not made aware of the changes in the installation of the temporary genset. LR was still under the understanding that it would be used only in the stand-alone mode. Characteristics of the electronic PCC, however, were such that the temporary genset was unable to automatically share and balance the load when working in parallel with the other SSGs.

Figure 2 - Arrangement of the temporary potentiometer on main switchboard

In order for two generators to work effectively in parallel, it is essential that they maintain their speed and balance the electrical load between them. To achieve this, their respective governors and control systems must be compatible and capable of working together. The temporary genset was unable to balance the load automatically and there was not enough time for the crew to respond to the unforeseen loss of the No. 1 SSG by manually taking up the load with the available potentiometer.

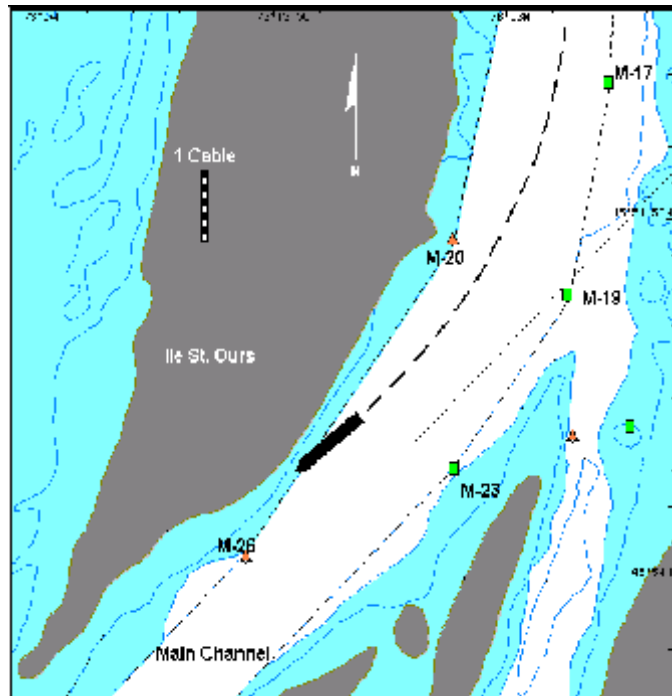
At the time of the blackout, the vessel was proceeding at 9.5 knots and on a starboard course alteration into Bellmouth curve (just southeast of Île Saint-Ours). The rudder, which was already to starboard due to the course alteration, caused the vessel to swing out of the channel and run aground in position

45° 54' 10"N; 073° 13' 26"W (see Figure 3).

Figure 3 - Ship's approximate track after blackout and grounding position
